June 26, 2018

Limited Structural Evaluation  
**City of Alachua Main Street Warehouse**  
14815 North Main Street  
Alachua, Alachua County, Florida  
GSE Project No. 13630

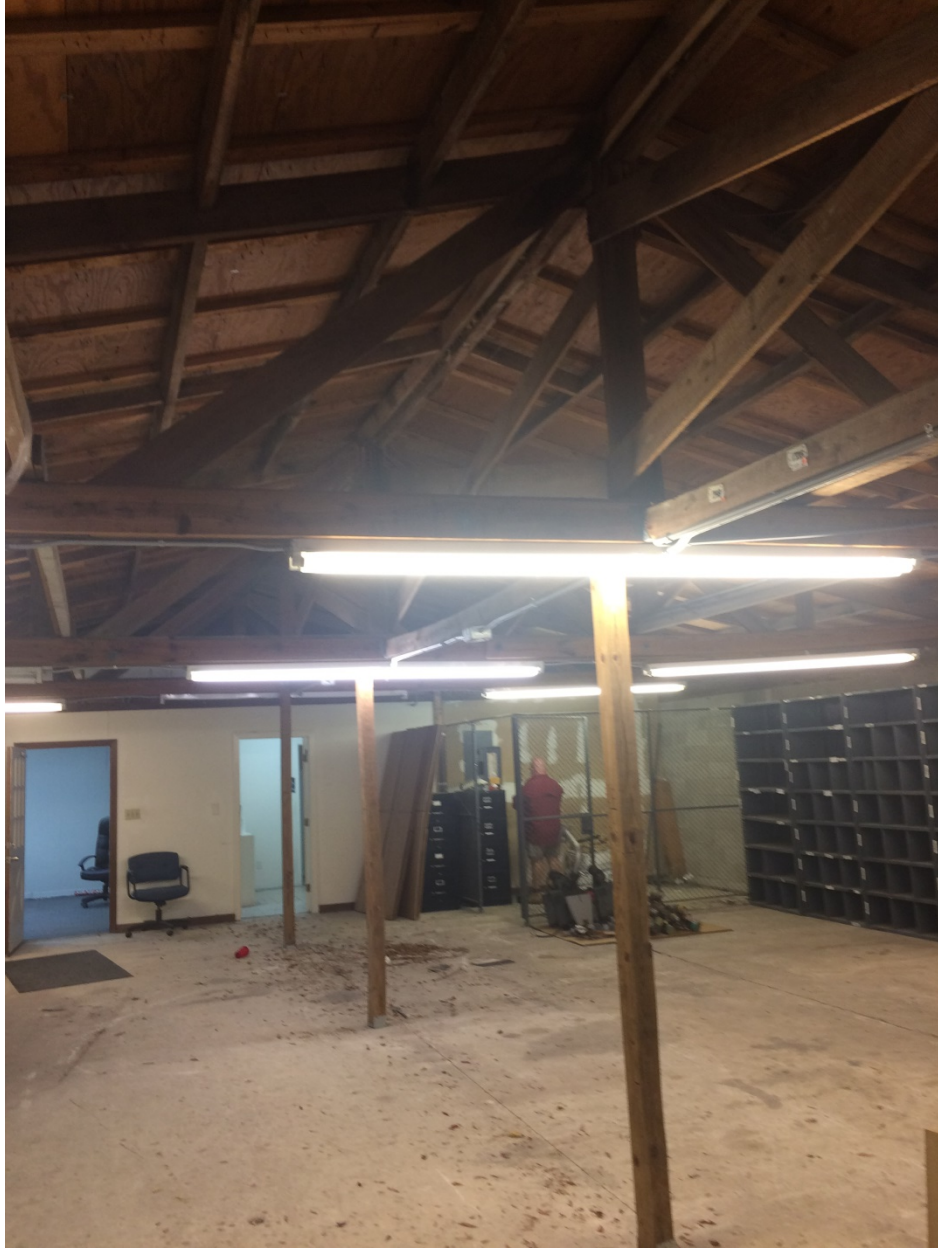
The structural framing and floor slab for the north warehouse portion of the building was uncovered and observable (see photo No. 1). The structural framing for the office areas on the south side (approximately 600 square feet) was covered by drywall, and the floors were covered with carpet (see photo No. 2). The foundation system for the load bearing block walls was buried and unobservable at the time of our site visit.

Picture 1  
Interior of Warehouse Portion

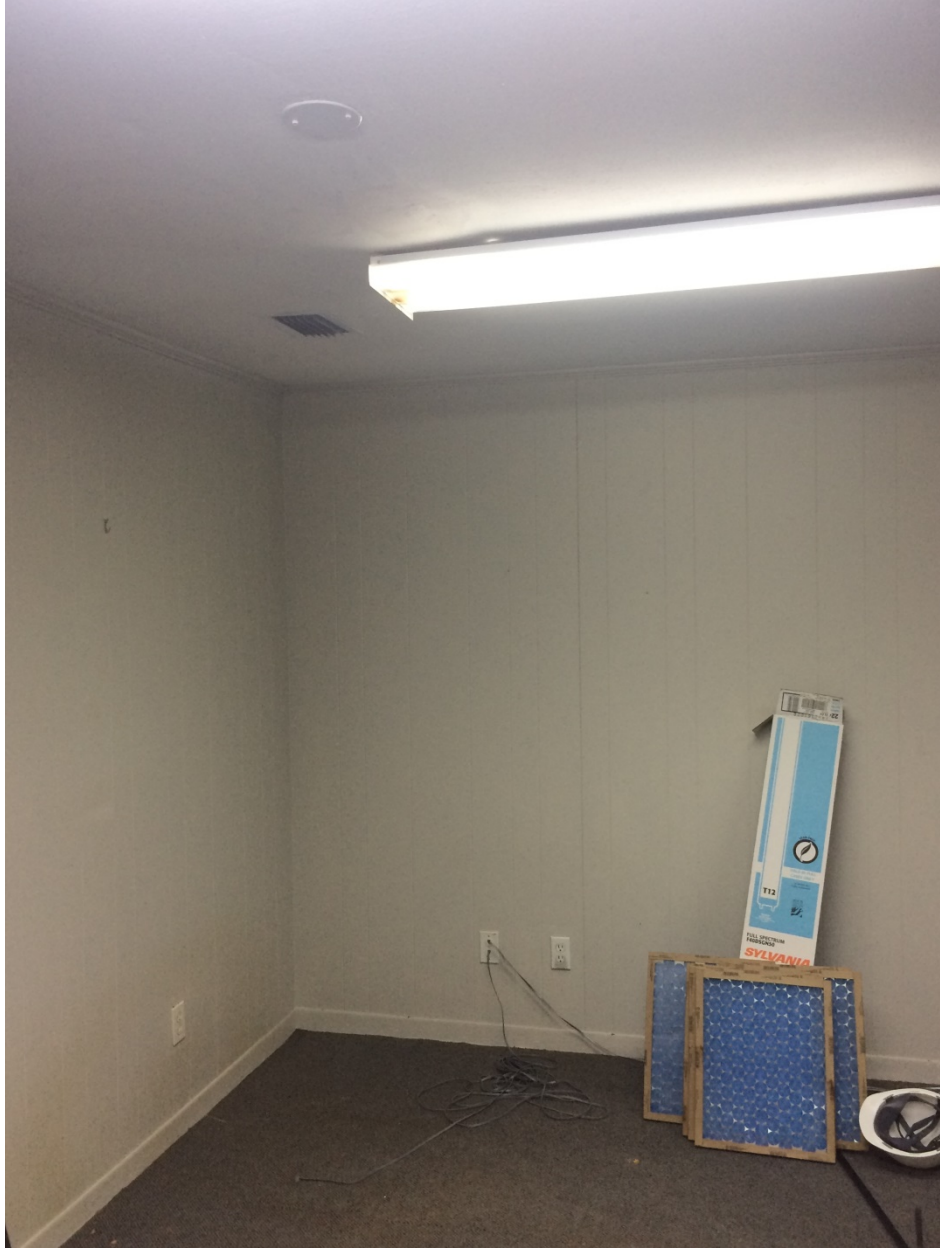
Picture 2  
Office Area

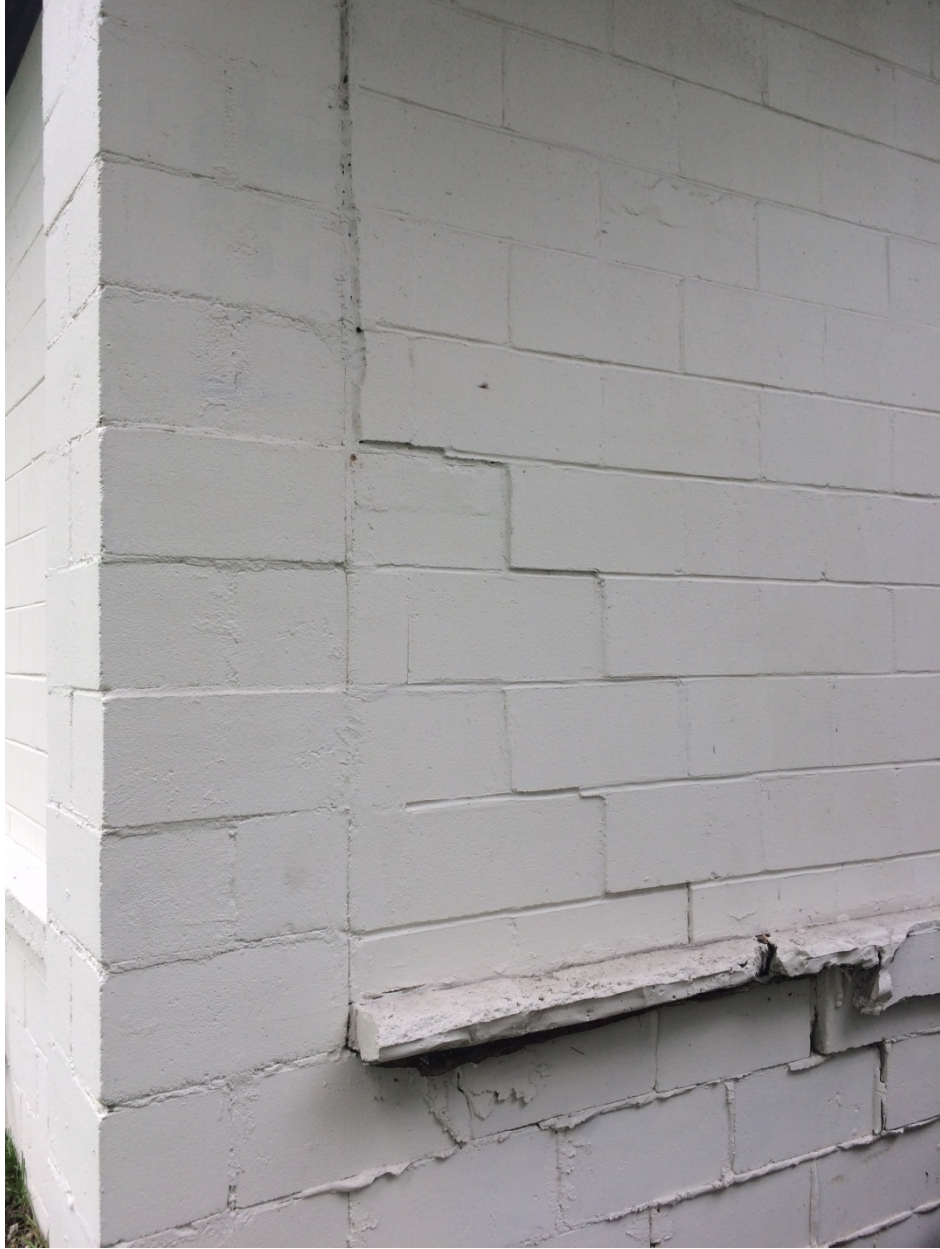
- The northeast corner had cracking damage to the concrete masonry unit (CMU) load bearing walls (see photo No. 3). This damage appears to be related to the root system of a large tree that was removed in the past, and had been previously repaired. The conditions of the repairs do not appear to be appreciably worse than the completed repairs would have looked like immediately after completion. Further destructive investigations are required to determine how the CMU walls in this area are reinforced. It is GSE's opinion that additional reinforcing is most likely required to bring the wall strength up to Code requirements.
- The roof system has large deflections throughout (see photo No. 4). This coincides with the deflections and design/construction observed inside the building. No appreciable roofing damage was observable from our vantage point on the ground.

Picture 3  
Northeast Corner CMU

To keep and use the existing CMU walls and foundations, additional destructive testing would be required to determine what modifications would be required. At the least, the CMU walls in the northeast corner would require added reinforcing grouted into the existing cells of the wall. We estimate the cost of the investigation and repairs to be on the order of \$20,000.

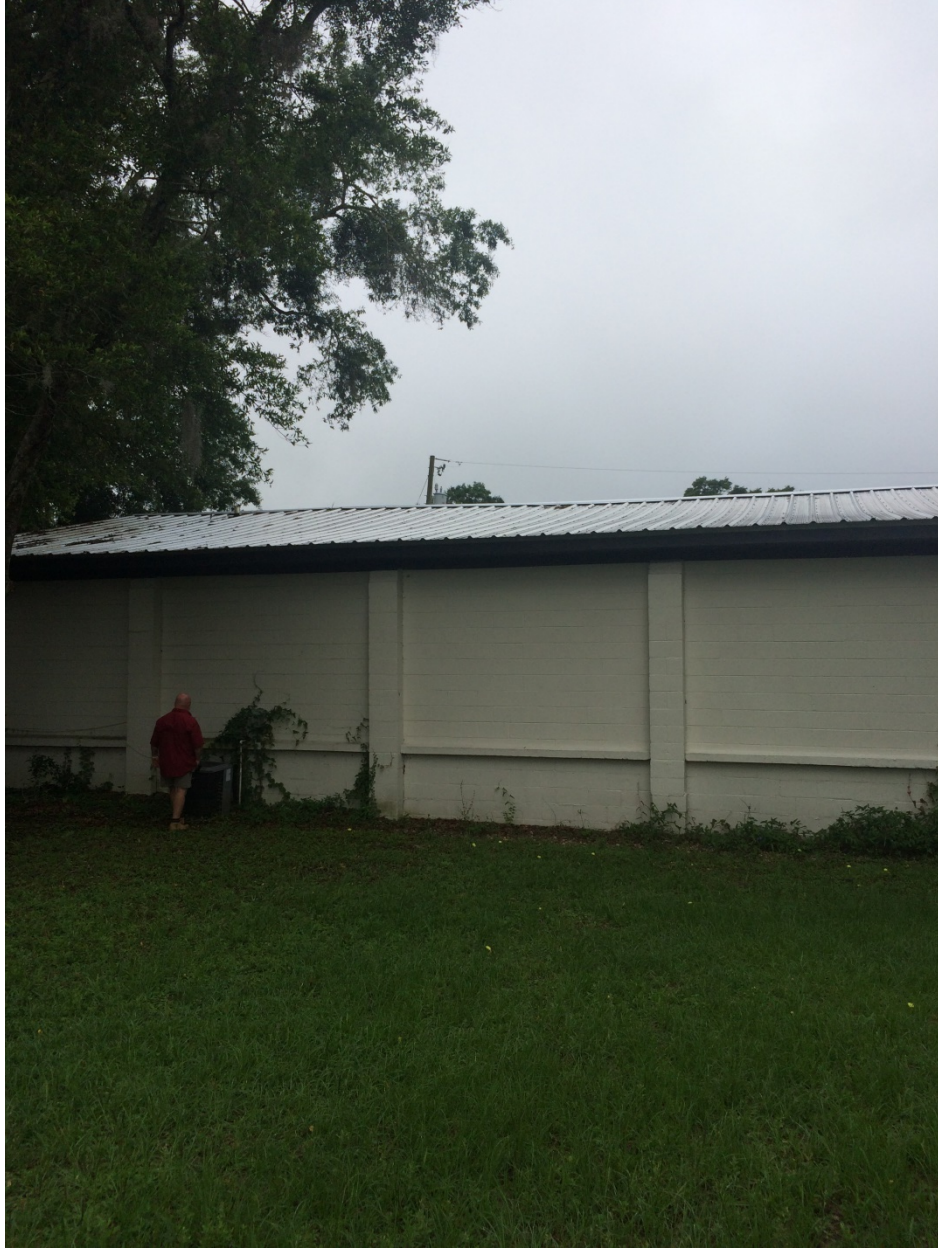
Picture 4  
Roof Deflection

The existing roof framing of the warehouse is considered inadequately designed and constructed, and requires complete replacement. During a wind event, the roof framing could pose a safety hazard for anyone occupying the building. We estimate the cost of demolition and replacement will be on the order of \$80,000.

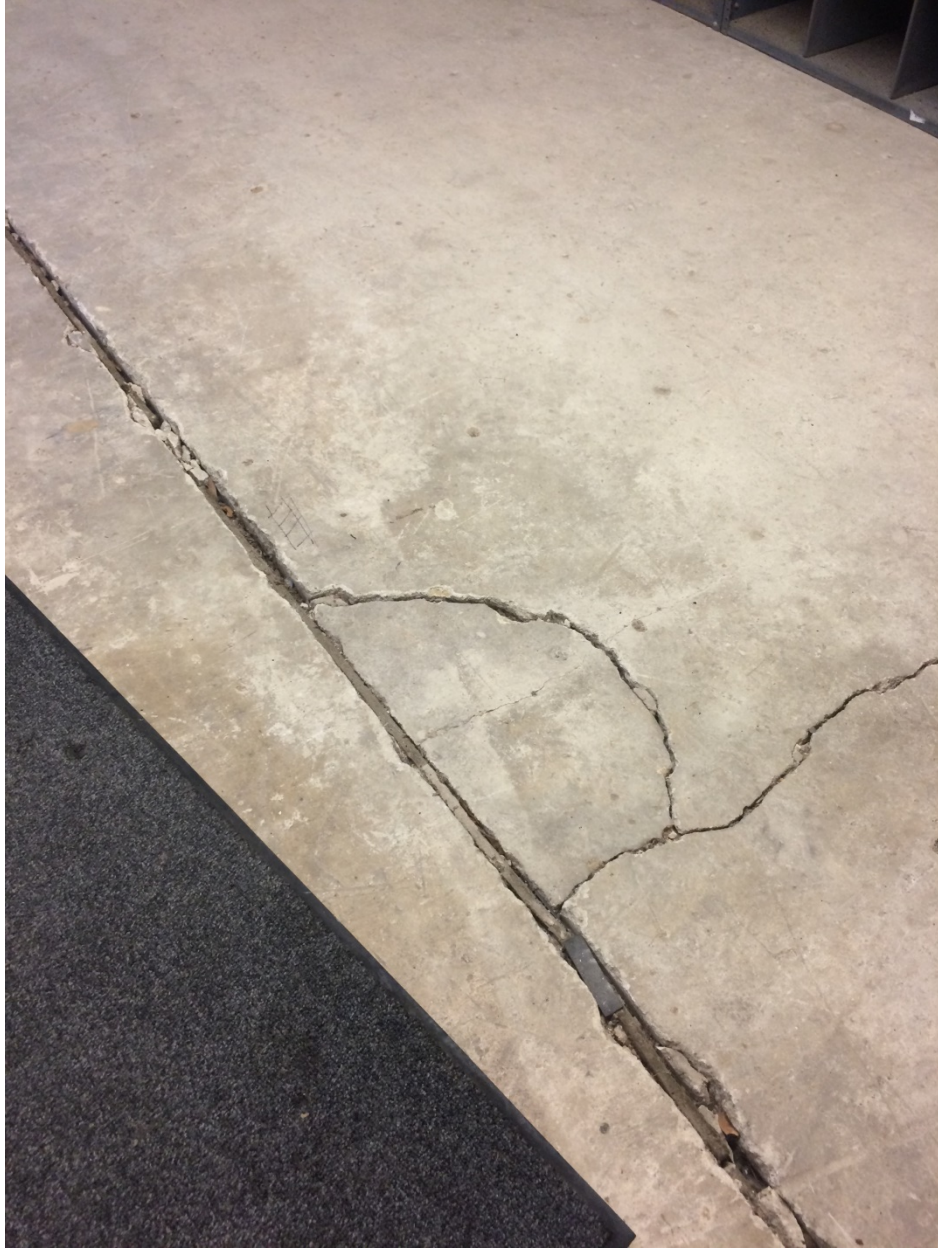
- The concrete floor slab in the warehouse area has significant cracking damage with vertical offsets that pose a safety hazard/tripping hazard (see photo No. 5). This slab will require replacement or the addition of a topping slab incorporating a self-leveling cementitious material.
- The roof framing system is inadequately designed/constructed, shows signs of excessive deflections, and according to the City has been modified to rectify problems with deflection in the past (see photos No. 6 thru No. 8). It is GSE's opinion that the roof framing system is insufficient to support the Code required roof loading, and requires complete replacement.
- The electrical wiring and HVAC system appear to require repairs and most likely will need replacement to bring them up to Code.

Picture 5  
Cracked Floor

The existing floor slab in the warehouse is a safety/tripping hazard, and requires replacement or the addition of a self-leveling cementitious topping. We estimate the cost of repairs for this portion of the building will be on the order of \$25,000.

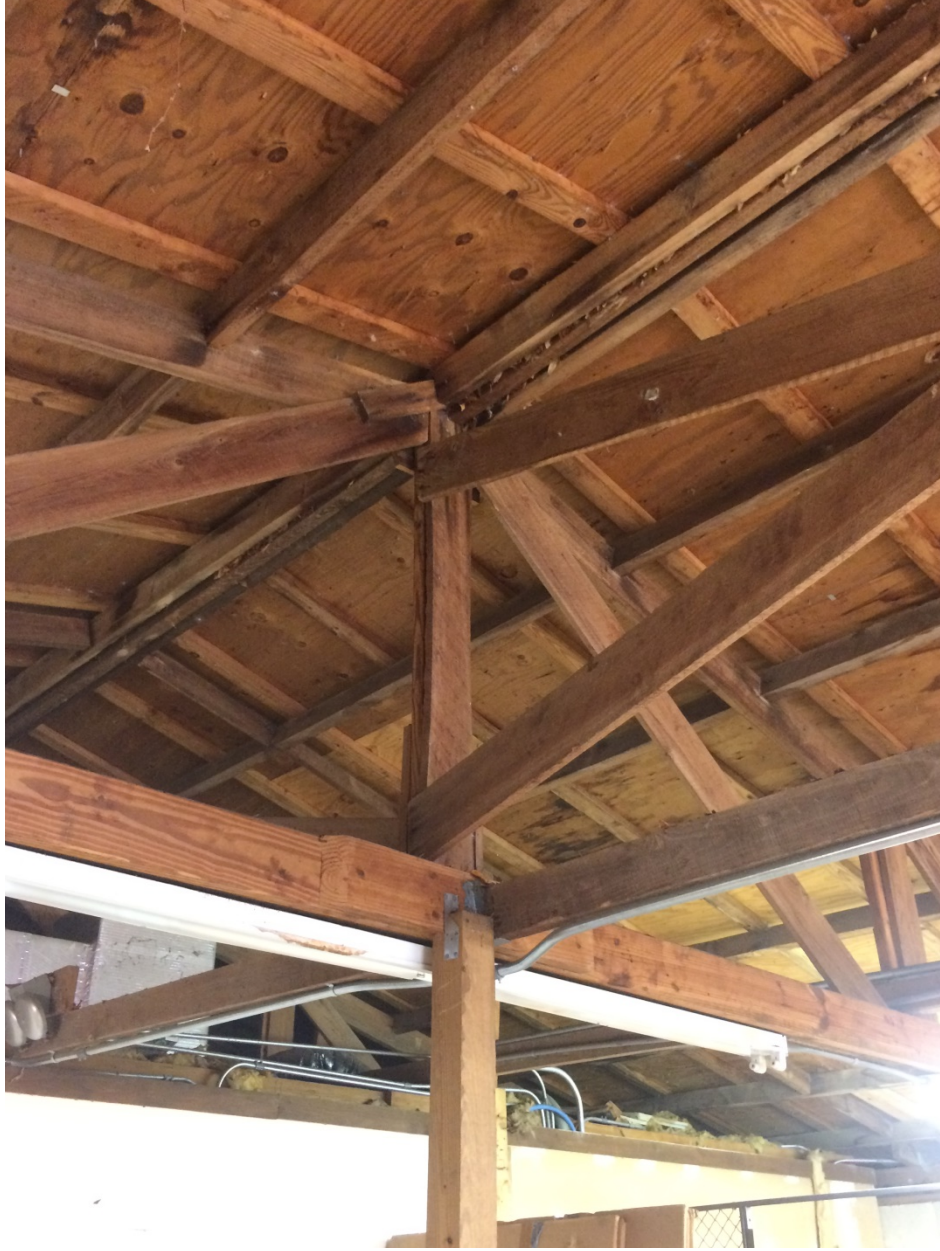
Picture 6  
Column to Shore Roof Framing

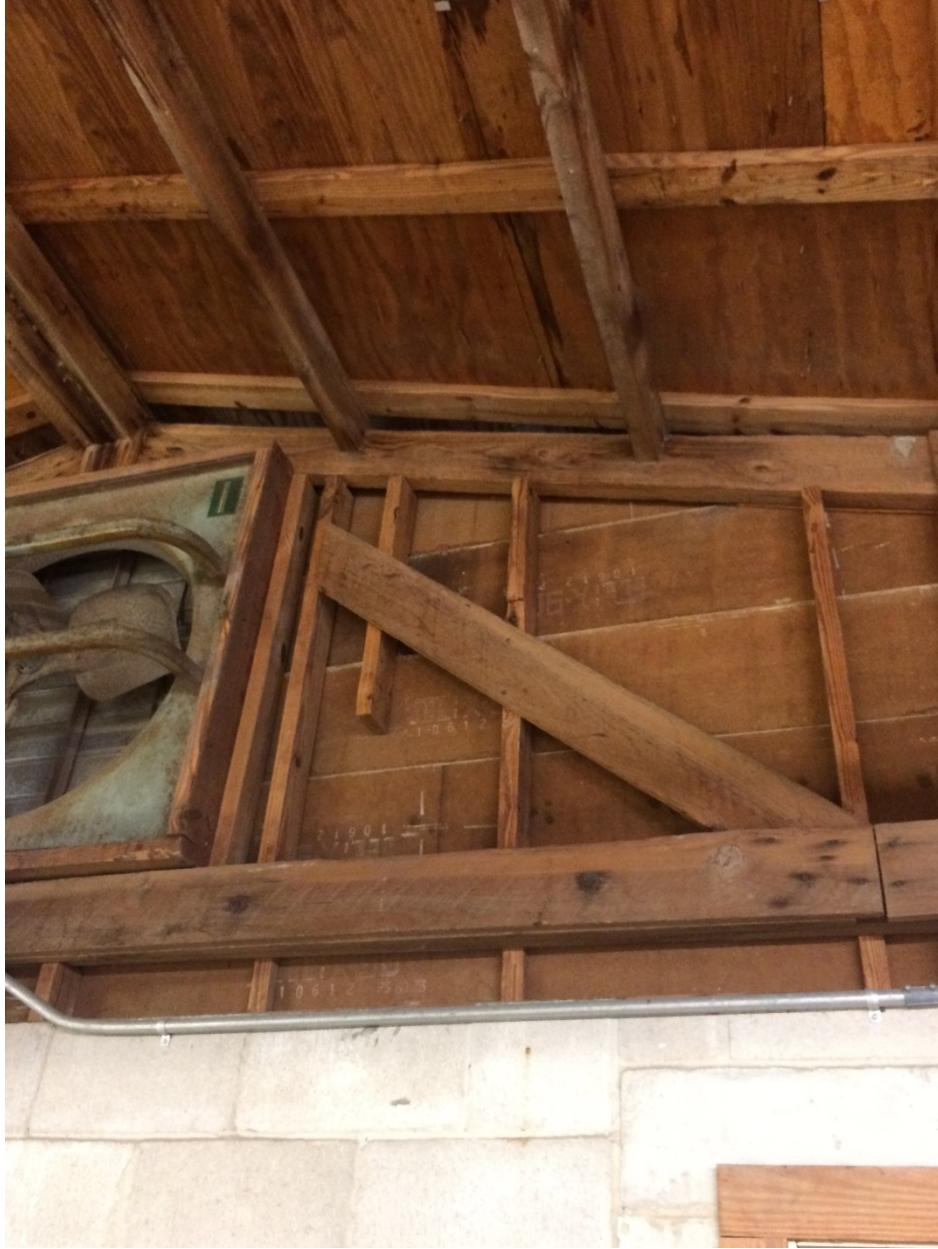
Picture 7  
Bracing Disconnected with Panel Points

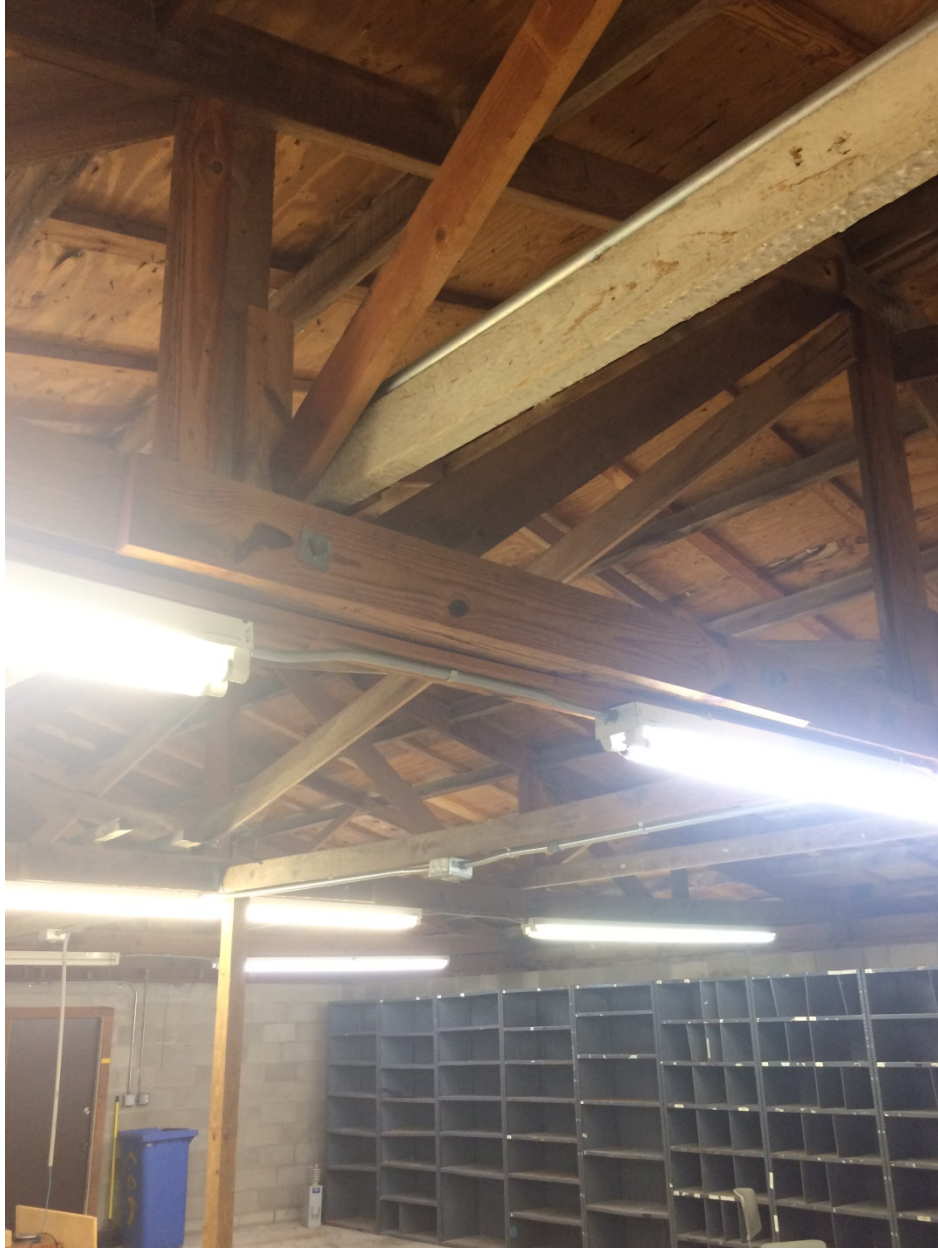
Picture 8  
Haphazard Bracing System
