Savannah Station – Phase 2

From: Tim Sagul
Date: October 29, 2018
RE: Savannah Station, Phase 2 - Preliminary Stormwater Management Design

ENVIRONMENTAL RESOURCE ASSESSMENT

Savannah Station Phase 2

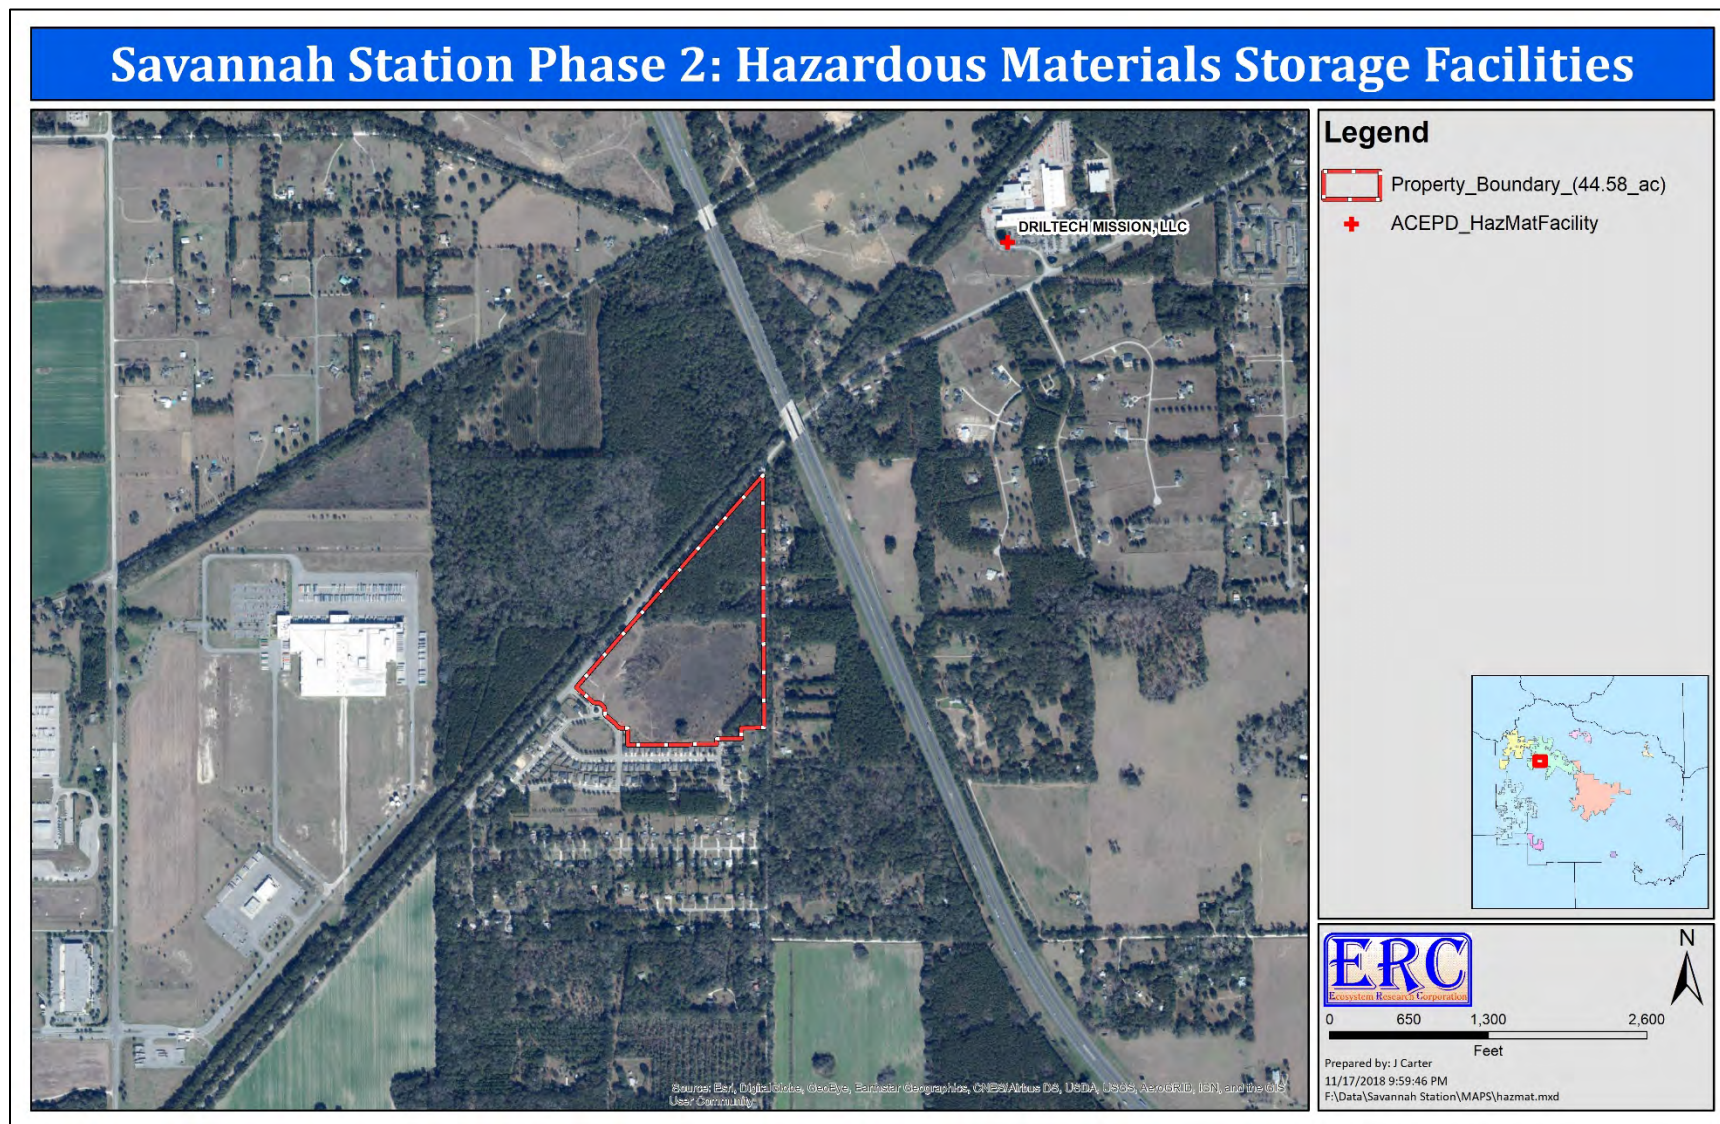
Figure 11. Alachua County hazardous materials storage facilities shown in relation to the Project Site.

The locations of Hazardous Materials Storage Facilities monitored by Alachua County are provided in the area of the Project Site are shown on **Figure 11**. The coverage shows there is one facility located ± 0.5 miles northeast of the Project Site, however, none are present in the immediate vicinity of the Project Site.

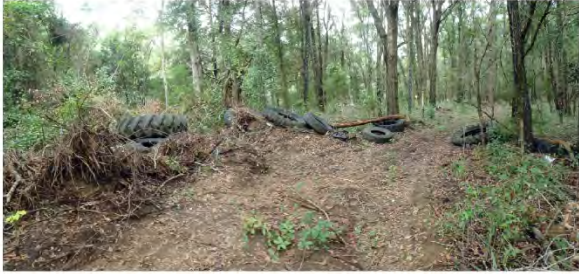
11/15/2018
Photo 1
1Frames 4776-4777 GPS 007 Tires and debris (North).jpg

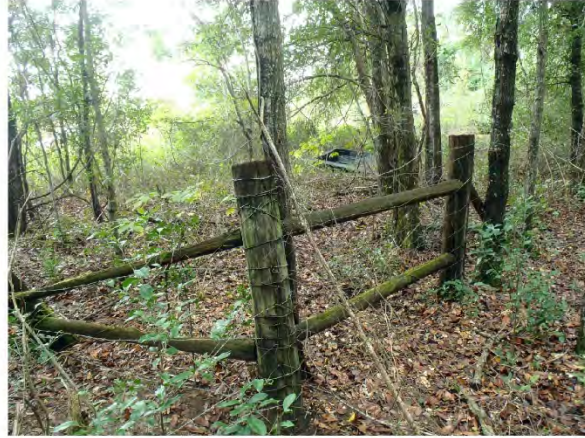
11/15/2018
Photo 2
2Frames 4778 GPS 019 Dog pen(Southwest).jpg

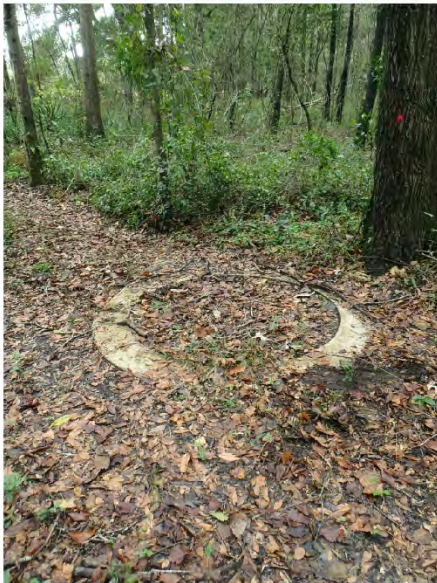
11/15/2018
Photo 3
3Frames 4779 GPS 032 Circular concrete structure.jpg

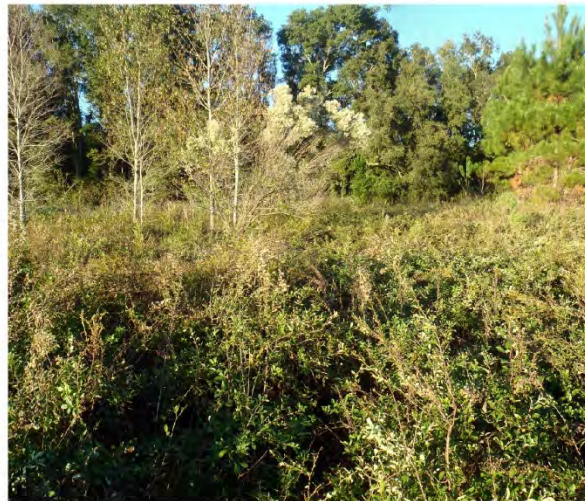
11/16/2018
Photo 12
12Frames 4793-4794 GPS 834 (PMW Unit) GT Habitat.jpg

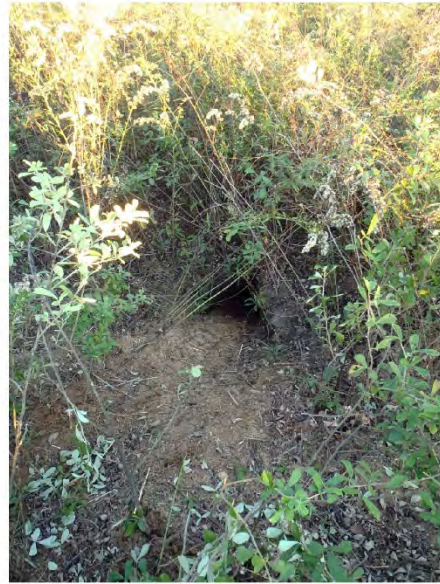
11/16/2018
Photo 14
14Frames 4797 GPS 811 (PMW Unit) GT-PO.jpg

There were gopher tortoise burrows found on the Project site. As a result of this finding, a 100% gopher tortoise survey will be required prior to development to locate **ALL** burrows present on the Project Site. The tortoises should be relocated to a conservation area pursuant to a relocation permit obtained from the Game Commission. The onsite habitat provides minimal support for this species. Further successional development of the site will result in degradation of the poor-quality habitat that currently exists so relocating the tortoises to a conservation area is the best available option to ensure their future survival. Prior to conducting a 100% survey, the Oldfield habitat should be mowed to increase the visibility of the burrows. Currently the existing vegetation and briers are so dense that burrows are extremely difficult to find.

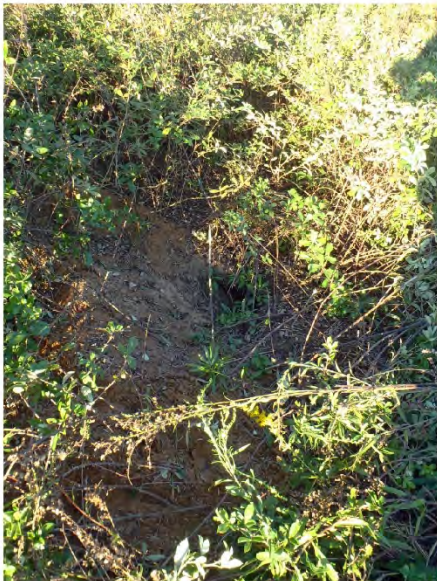
11/16/2018
Photo 15
15Frames 4792 GPS 834 (PMW Unit) GT-PO.jpg

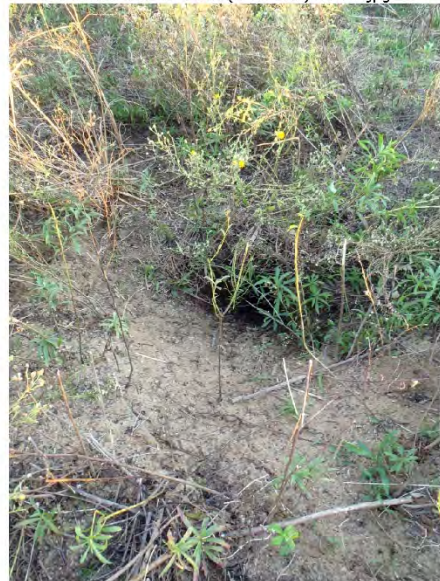
11/16/2018
Photo 16
16Frames 4798 GPS 925 (PMW Unit) GT-PO.jpg
